# Testing EEMPA at the National Carbon Capture Center

“Engineering-Scale Test of a Water-Lean Solvent for Post-Combustion Capture”

Award No. DE-FE0031945

Electric Power Research Institute

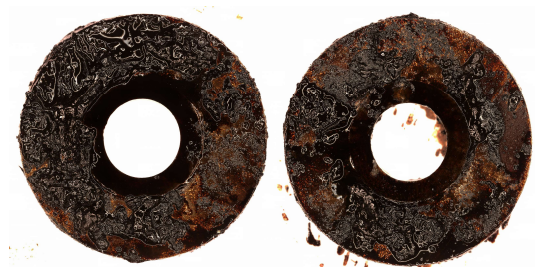
Optical micrographs of corrosion coupons after removal from the bottom of the regenerator section at the end of the test campaign. They were coated with a very viscous material suspected to be formed via decomposition of the solvent.

Qualitative observations suggest that the solvent may have undergone higher-than-expected thermal degradation. The primary evidence of this was the discovery of dark, viscous deposits in the PSTU, primarily in the bottom of the regenerator section. Figure 18 shows photographs of two of the corrosion coupons that were installed in the lean solvent line connecting the sump of the regenerator column with the lean solvent pump. They were coated with a viscous material presumed to originate from degradation of EEMPA.

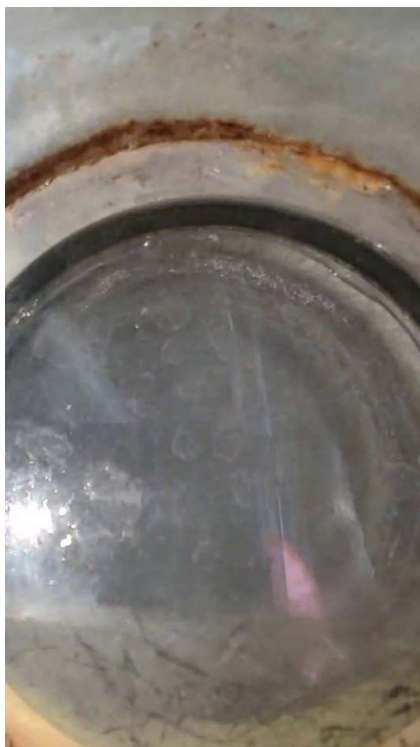
Figure 25  
Picture of fog taken October 18, 2024 (courtesy of NCCC).

Concomitant with the observation of the liquid carryover into the product line, NCCC staff observed a dense fog inside the regenerator through three sight glasses installed at different points along the vessel. The fog appeared as a dense dispersion of fine white liquid droplets and typically completely obscured any ability to see into the regenerator vessel. At best, some liquid draining down the walls near the sight glass ports in the middle and bottom of the regenerator would be visible.
